8 (1)
AD 73767
MISCELLANEOUS PAPER NO. 4-886

EVALUATION OF THREE-PIECE AM2 ALUMINUM LANDING MAT

W. N. Brabston

April 1967

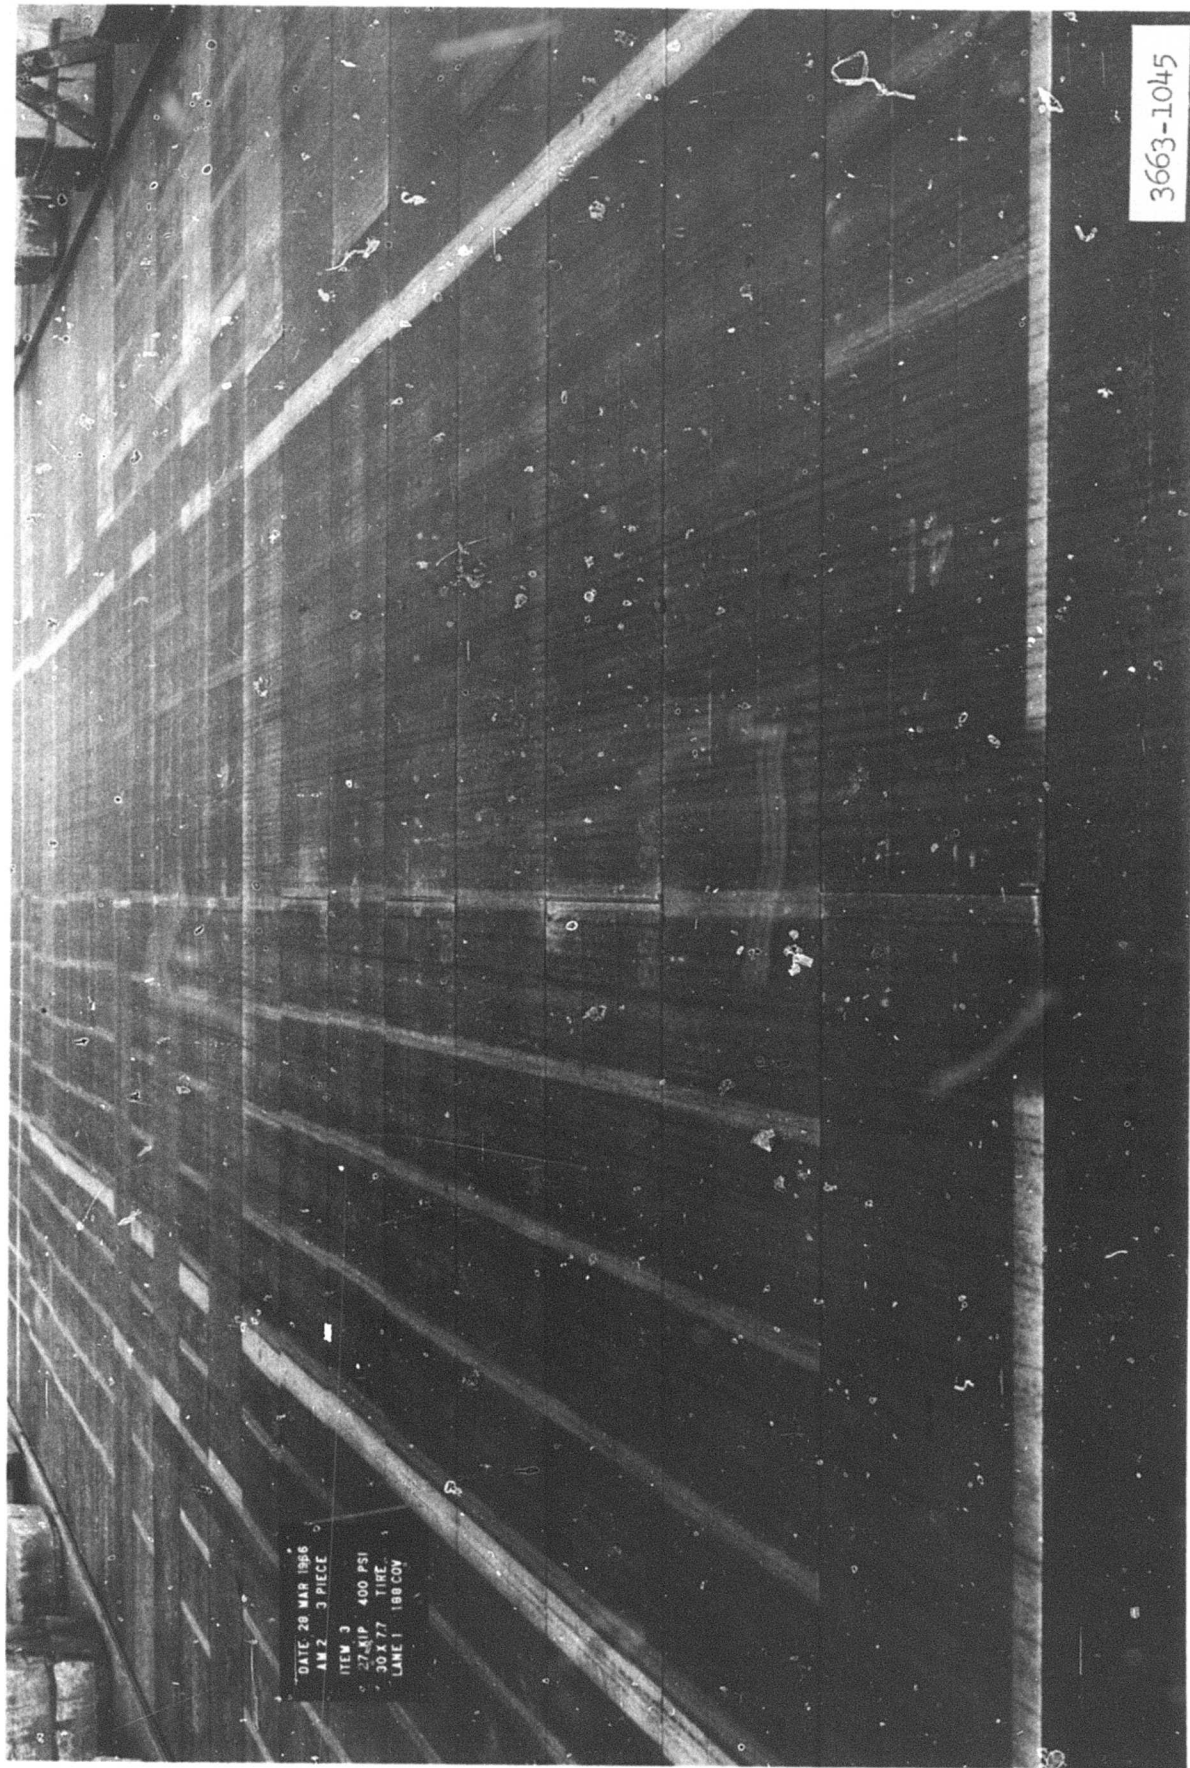
planks 98, 102, and 106 failed from end-connector weld failure. At 188 coverages, traffic was stopped with the item in serviceable condition (photograph 14). At 188 coverages, there were seven end-connector weld cracks which averaged 9 in. in length.

Photograph 14. Item 3, lane 1, after 188 coverages

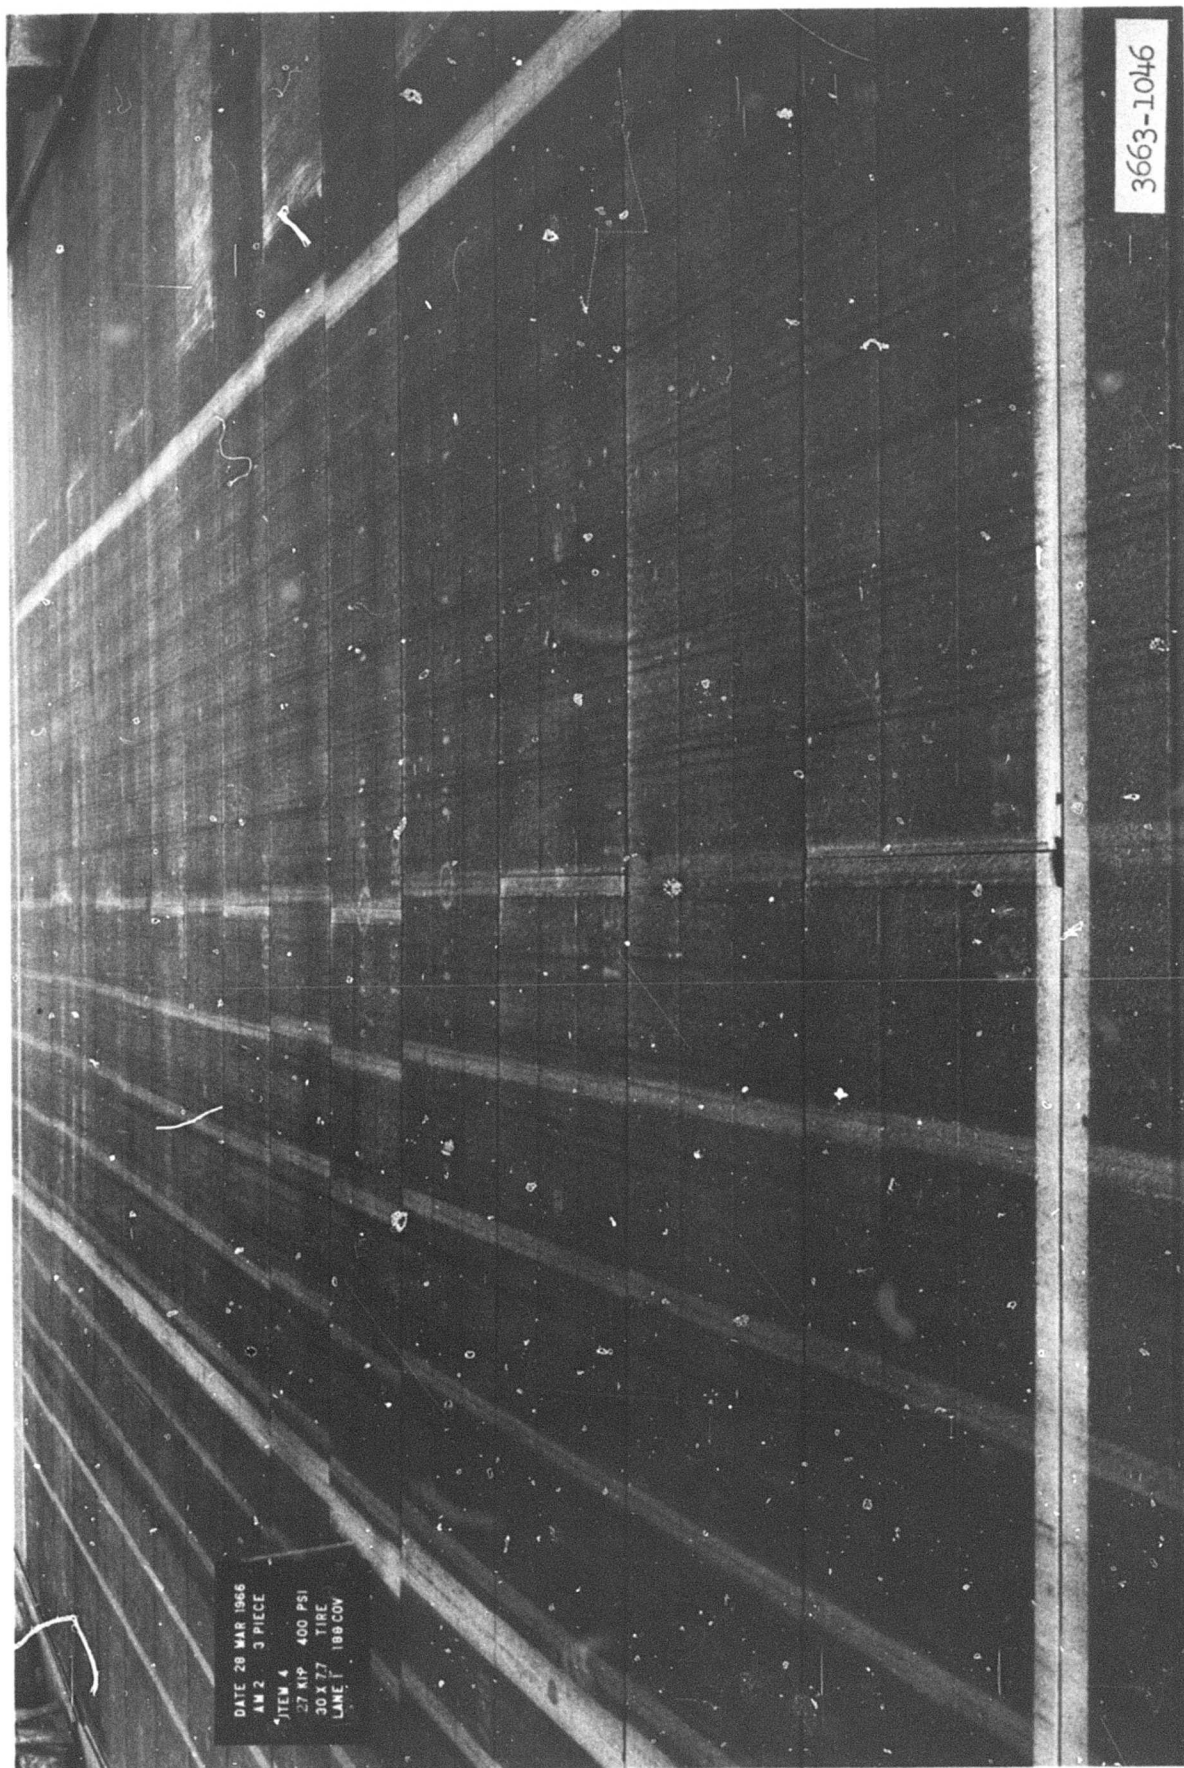
24. Item 4. A general view of item 4 prior to traffic is shown in photograph 15. The item withstood 188 coverages of traffic with only one break, an end-connector weld break in plank 122. The crack appeared in the weld at eight coverages and was approximately 1/2 in. in length. When traffic was stopped at 188 coverages, the crack had progressed to 2 in. There were no other breaks in the item, which was in excellent condition (photograph 16). It was noticed during the traffic test that the mat deflected considerably under the test load vehicle. The deflection increased as the test progressed and the sand subgrade consolidated under the mat.

Photograph 16. General view of item 4, lane 1, after 188 coverages

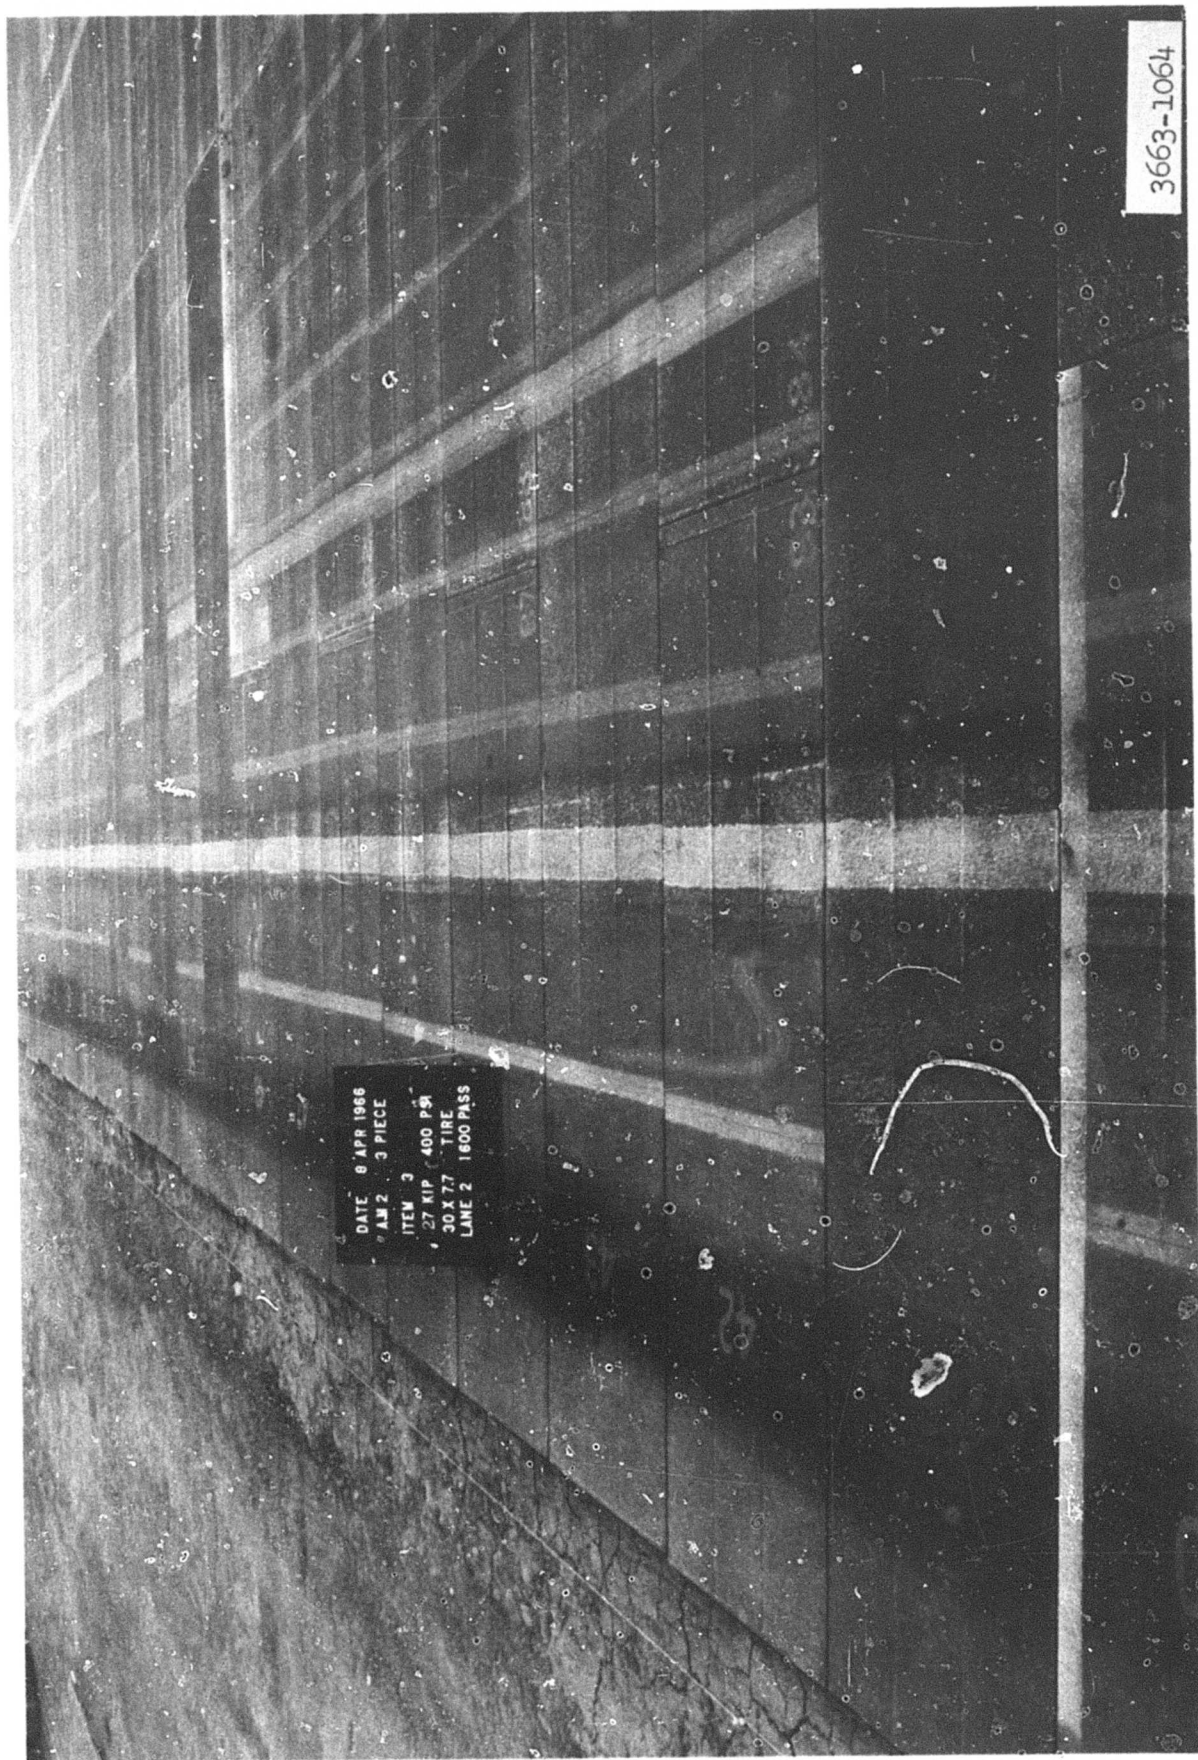
30. Item 3. Item 3 withstood 1600 passes of traffic with no apparent mat damage. Views of item 3 before and after the traffic test are shown in photographs 25 and 26, respectively.

Photograph 26. Item 3, lane 2, after 1600 passes
